Wetland Delineation Report Driggs Reed Memorial Airport

August 2020

Driggs Reed Memorial Airport Expansion Teton County, Idaho

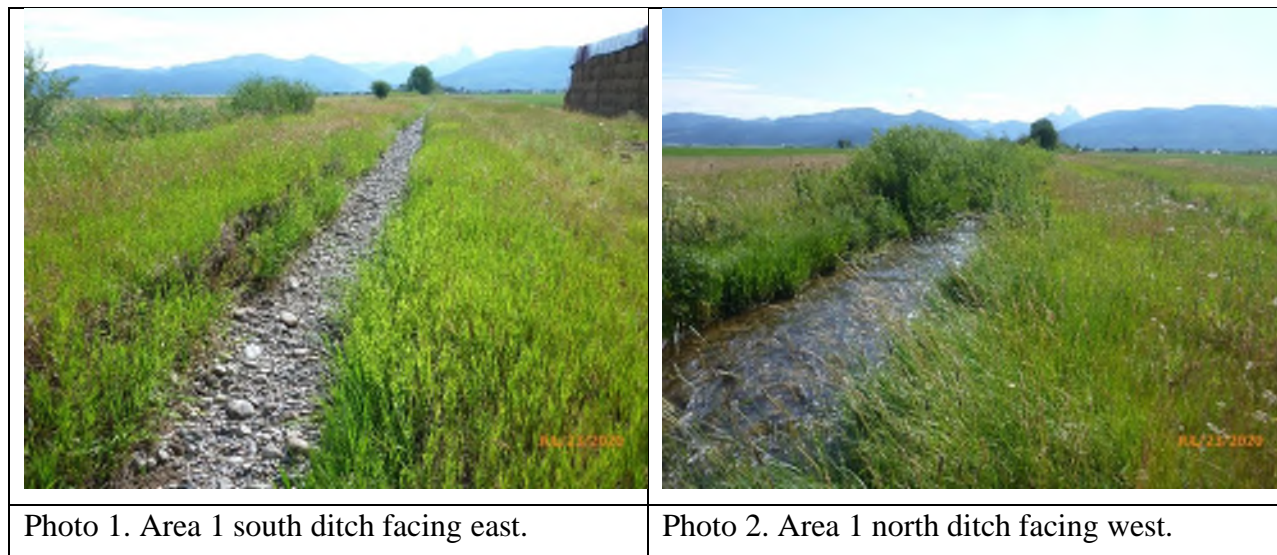
Area 1 consists of two parallel irrigation ditches (north and south ditch) that consist of steep banks which extend up from the ordinary high-water mark within the channels. On the south irrigation ditch the wetlands vegetation extends out from the banks of the ditch two feet and the open water channel was approximately four feet in width for the length of the ditch for a total delineated width of eight feet. The delineated wetland boundaries on the adjacent north ditch extend out from the edge of the banks three feet on each bank. The open water portion of the channel averages six feet in width for a total width of the delineated area for the north ditch of 12 feet wide. The two ditches are separated by approximately 10 feet which is comprised of upland habitat. Photos 1 and 2 show the delineated areas.

Photo 1. Area 1 south ditch facing east.

Photo 2. Area 1 north ditch facing west.

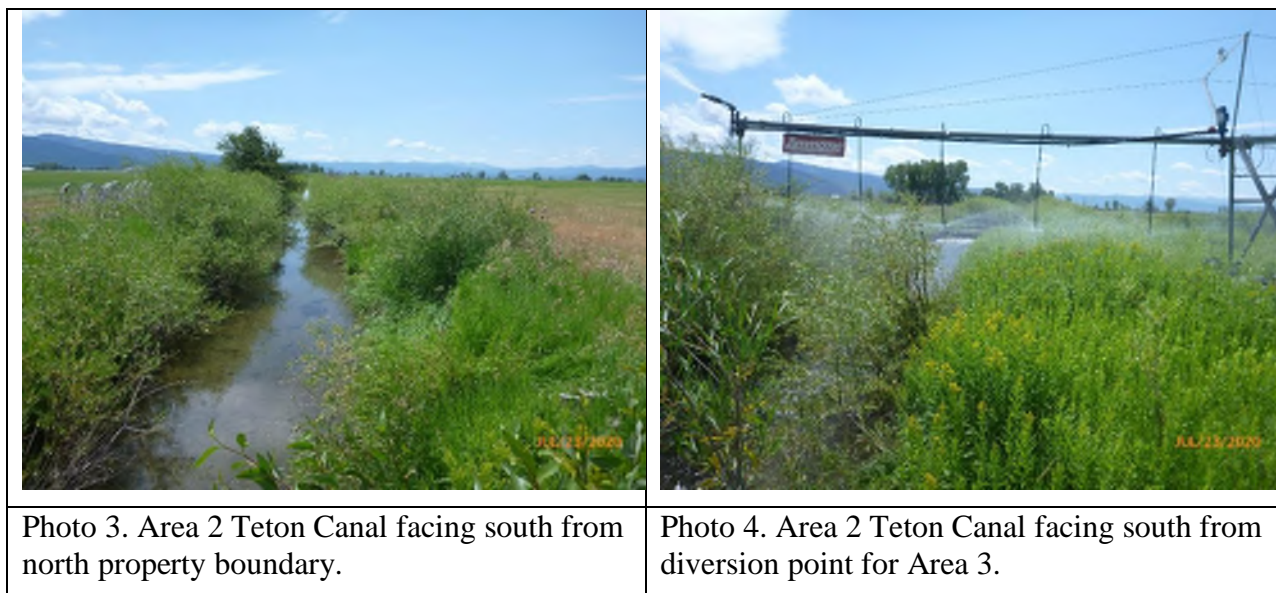
Area 2 is associated with the banks of the Teton Canal as it flows from south to north along the eastern boundary of the project area. The banks of the canal are steep and are vegetated from the ordinary high-water mark within the canal channel. The open water portion of the channel averages ten feet in width with vegetated banks extending out approximately six feet on each bank for a total width of the delineated area of 22 feet wide. Photos 3 and 4 show the delineated areas.

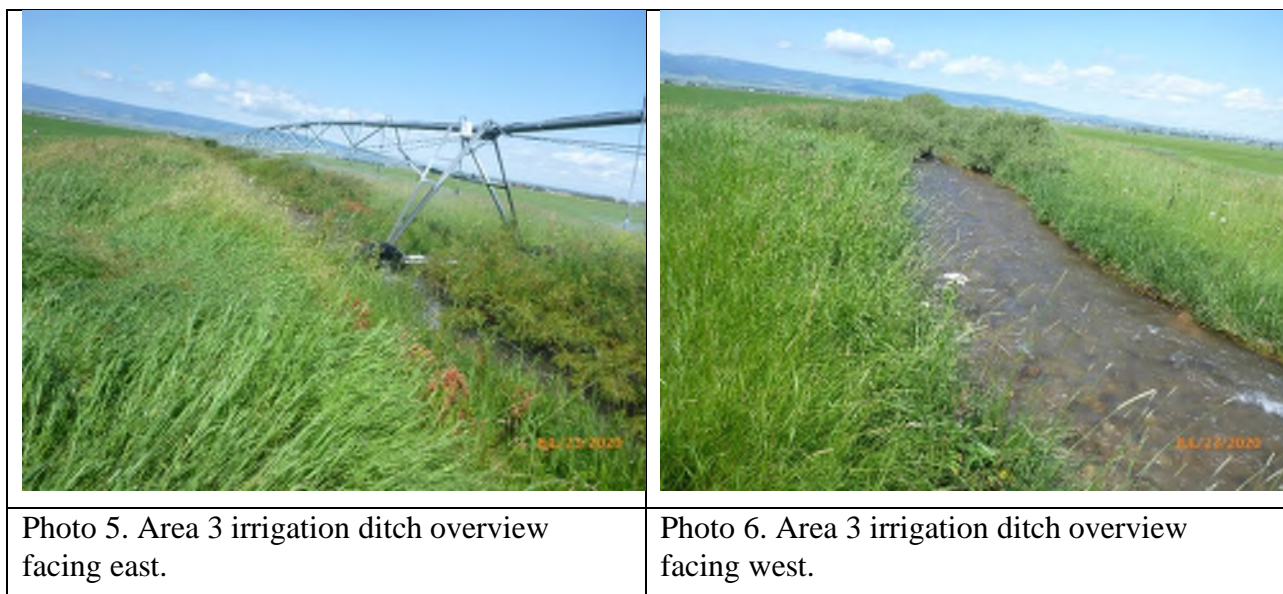
Area 3 consists of a single irrigation ditch comprised of steep banks that extend up from the ordinary high-water mark within the channel. The delineated wetland boundaries on the irrigation ditch associated with Area 3 extend out from the edge of the banks four feet on each bank. The open water portion of the channel averages six feet in width for a total width of the delineated area of 14 feet. Photos 5 and 6 show the delineated areas.

Photo 5. Area 3 irrigation ditch overview facing east.

Photo 6. Area 3 irrigation ditch overview facing west.

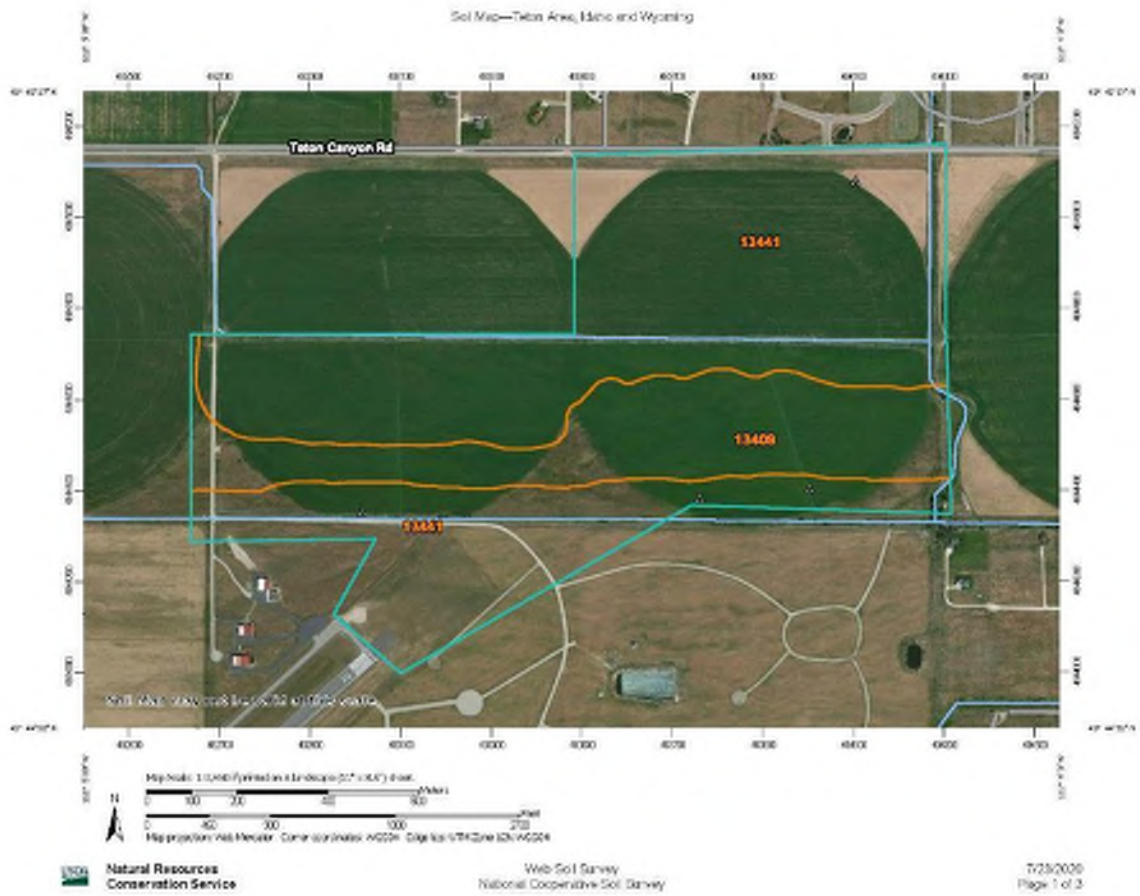
Figure 5. Soil Map of Project Area

Map Unit Symbol	Map Unit Name	Acres in AOI	Percent of AOI
13409	Snyderville gravelly loam, 0 to 4 percent slopes	66.2	23.2%
13441	Alpine-Driggs complex, 0 to 2 percent slopes	218.6	76.6%
Totals for Area of Interest		284.7	100.0%

The soils in the project area have been officially mapped by the NRCS (USDA 2019). The dominant soil within the project area is Alpine-Driggs complex, 0 to 2 percent slopes with a secondary soil of Snyderville gravelly loam, 0 to 4 percent slopes (See Appendix C). This soil consists of deep, well drained soils derived from mixed alluvium.
