2.0 INVENTORY

This chapter documents the type and general condition of the existing facilities at the Durango-La Plata County Airport (DRO or Airport) as of July 2014. It is meant to capture a snapshot in time and it is possible that some items referenced here may change by the completion of the Master Plan. The inventory is a complete compilation of all facilities and systems of the Airport, including airfield, terminal area, navigational aids (NAVAIDs), ground access, parking, pavement conditions, utilities, and other characteristics.

Durango-La Plata County Airport Master Plan

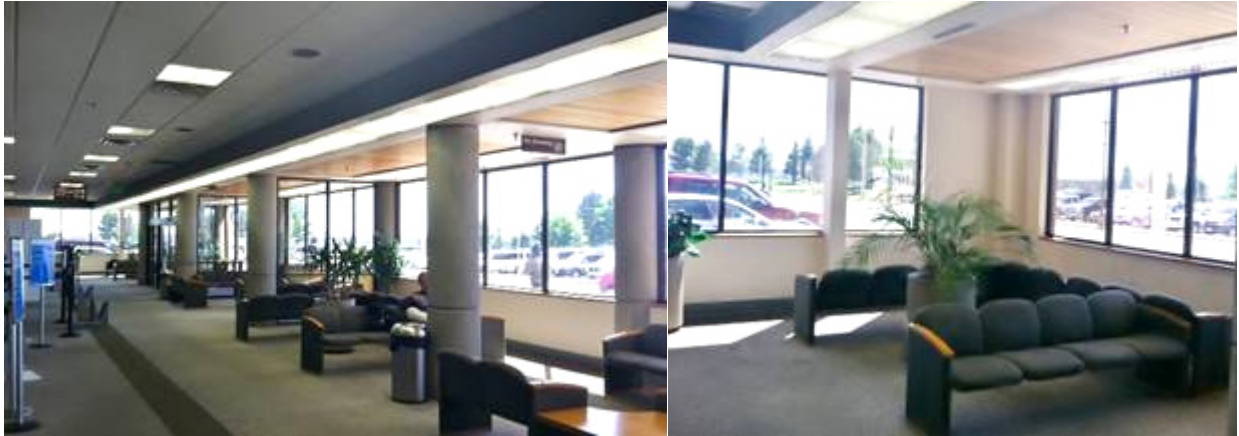
FIGURE 2-11 – WAITING AREAS

The ticketing lobby and circulation area offers space for passenger queuing, waiting, and circulation. Two designated waiting areas, northern and southern, divided by an entry, are located on the west wall, with windows facing the curbside and main parking lot (see **Figure 2-11**).

Passenger queuing and circulation space is shared as no division between the two areas exists. Consequently, when the queuing expands, circulation decreases.

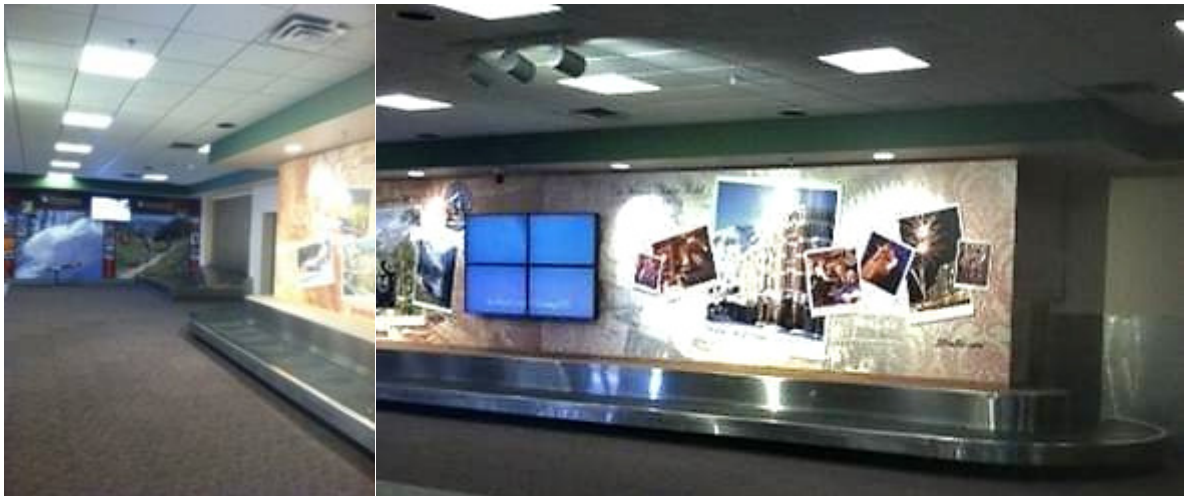
FIGURE 2-12 – BAGGAGE CLAIM

The baggage claim lobby is located in the north concourse, adjacent to the rental car offices. Passengers can claim their baggage from two devices: a straight conveyor belt or a large bag drop, depicted in **Figure 2-12**.

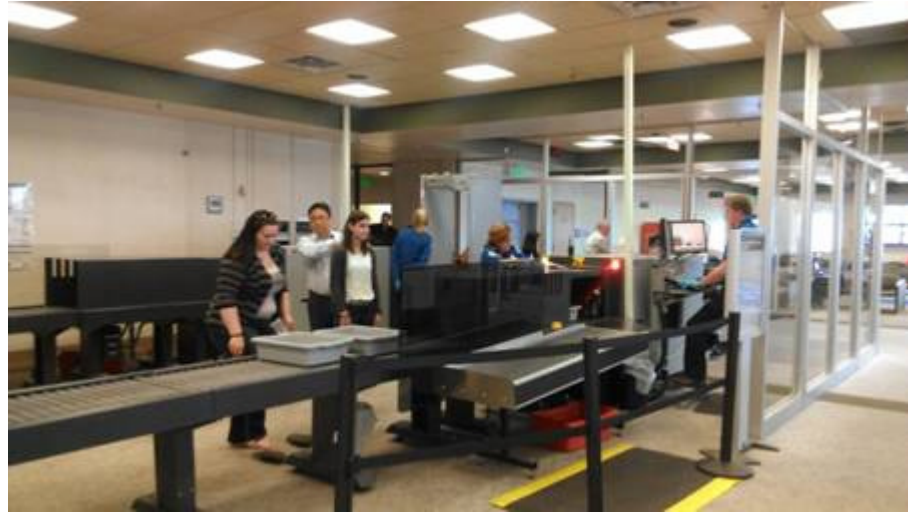
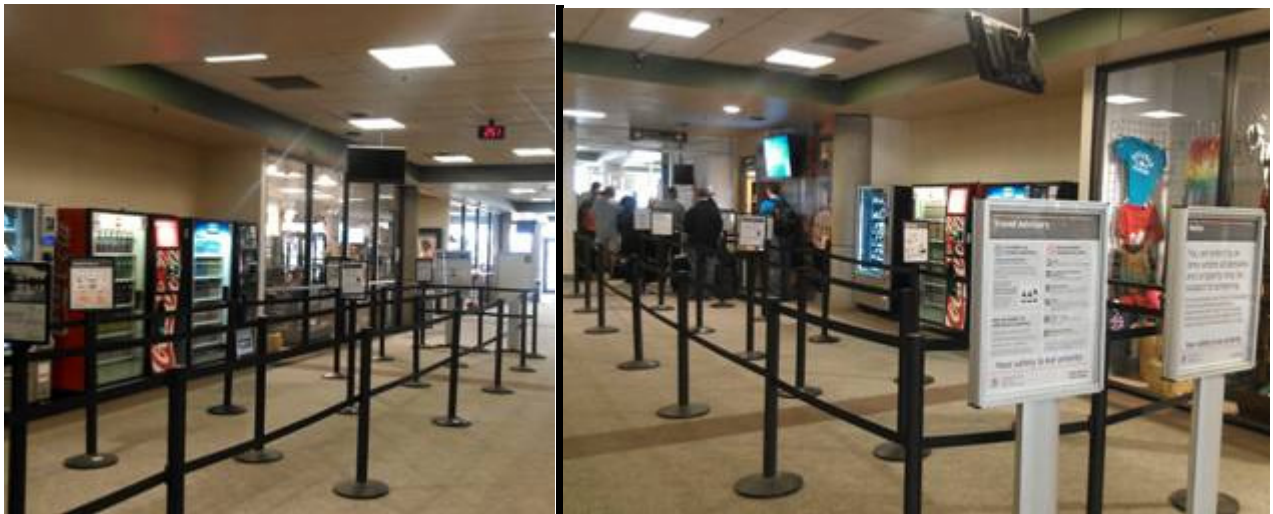
FIGURE 2-13 – PASSENGER SCREENING

The TSA occupies three main areas at DRO: passenger screening, baggage screening, and administrative space. The passenger screening area occupies the main central corridor and a large portion of the departure lounge. It is equipped with two checkpoint x-ray scanners and one magnetometer (depicted in **Figure 2-13**).

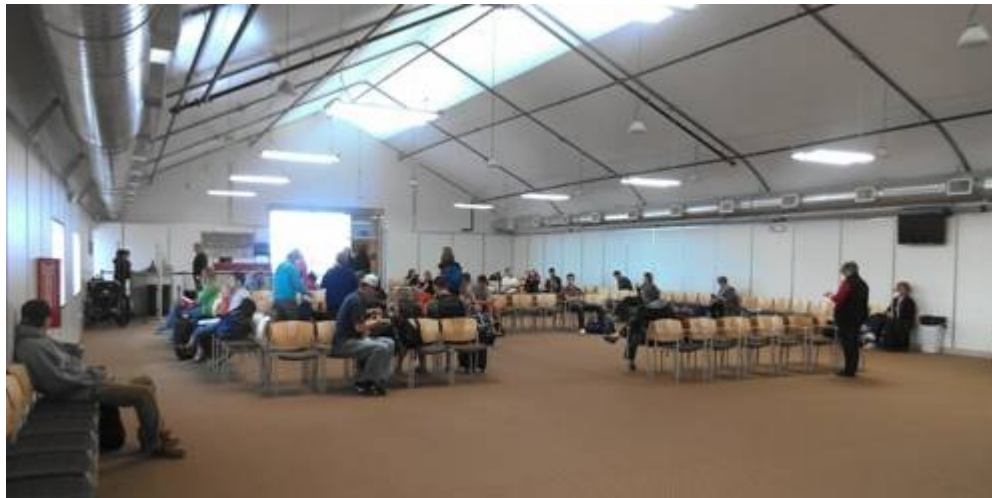
FIGURE 2-14 – TEMPORARY HOLD ROOM

The terminal departure lounges are 2,812 square feet and are reserved for scheduled outgoing passengers waiting to access their aircraft through one of four gates. As this area was too small to accommodate existing passengers, a temporary hold room and mobile restrooms were added in 2013 in response to rapid growth and TSA expansion into the departure lounge. **Figure 2-14** depicts the interior of the temporary hold room.

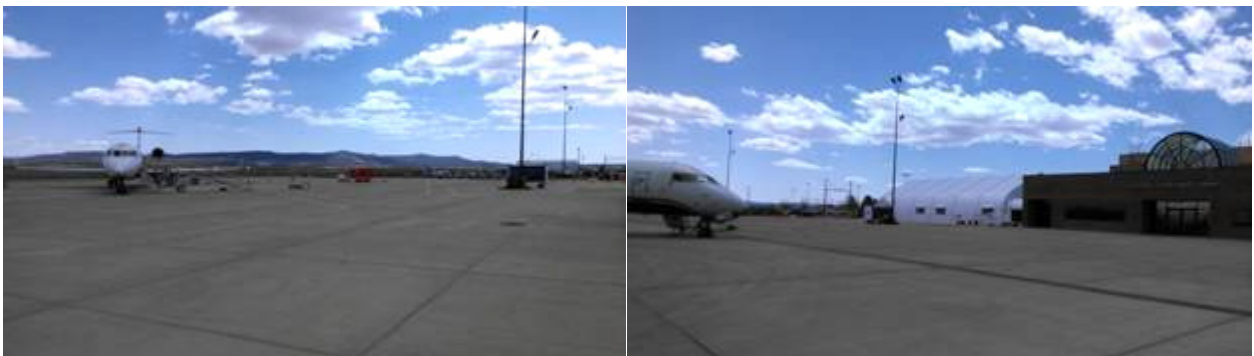
FIGURE 2-15 – COMMERCIAL AIRCRAFT PARKING

Figure 2-15 depicts an aircraft parked outside the terminal. The concourse does not have any passenger loading bridges (PLB). Passengers use four gates, specific to each airline, that provide ground access to the aircraft on the apron. Access to the aircraft is by air stairs from the apron.

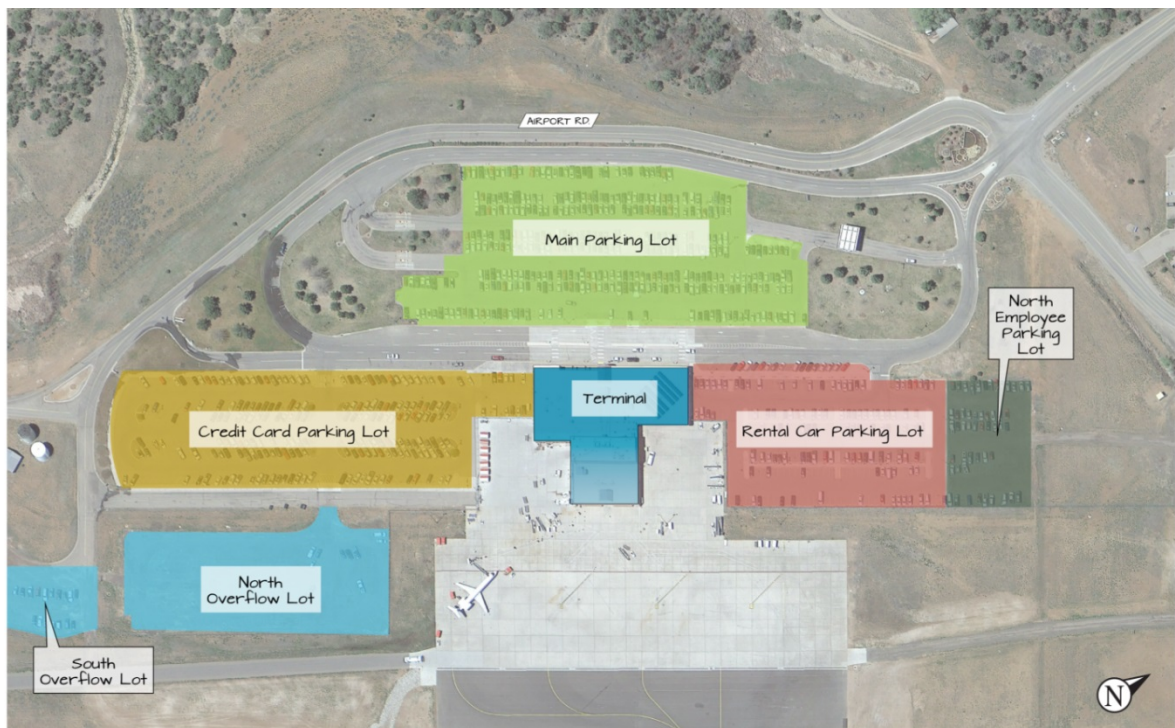
FIGURE 2-18 – PARKING LOTS

Employee parking is located in two locations. The south parking area is located on the north end of the credit card lot, closest to the terminal building. The north lot is located north of the rental car lot and is an unpaved lot covered with roto-milled asphalt.

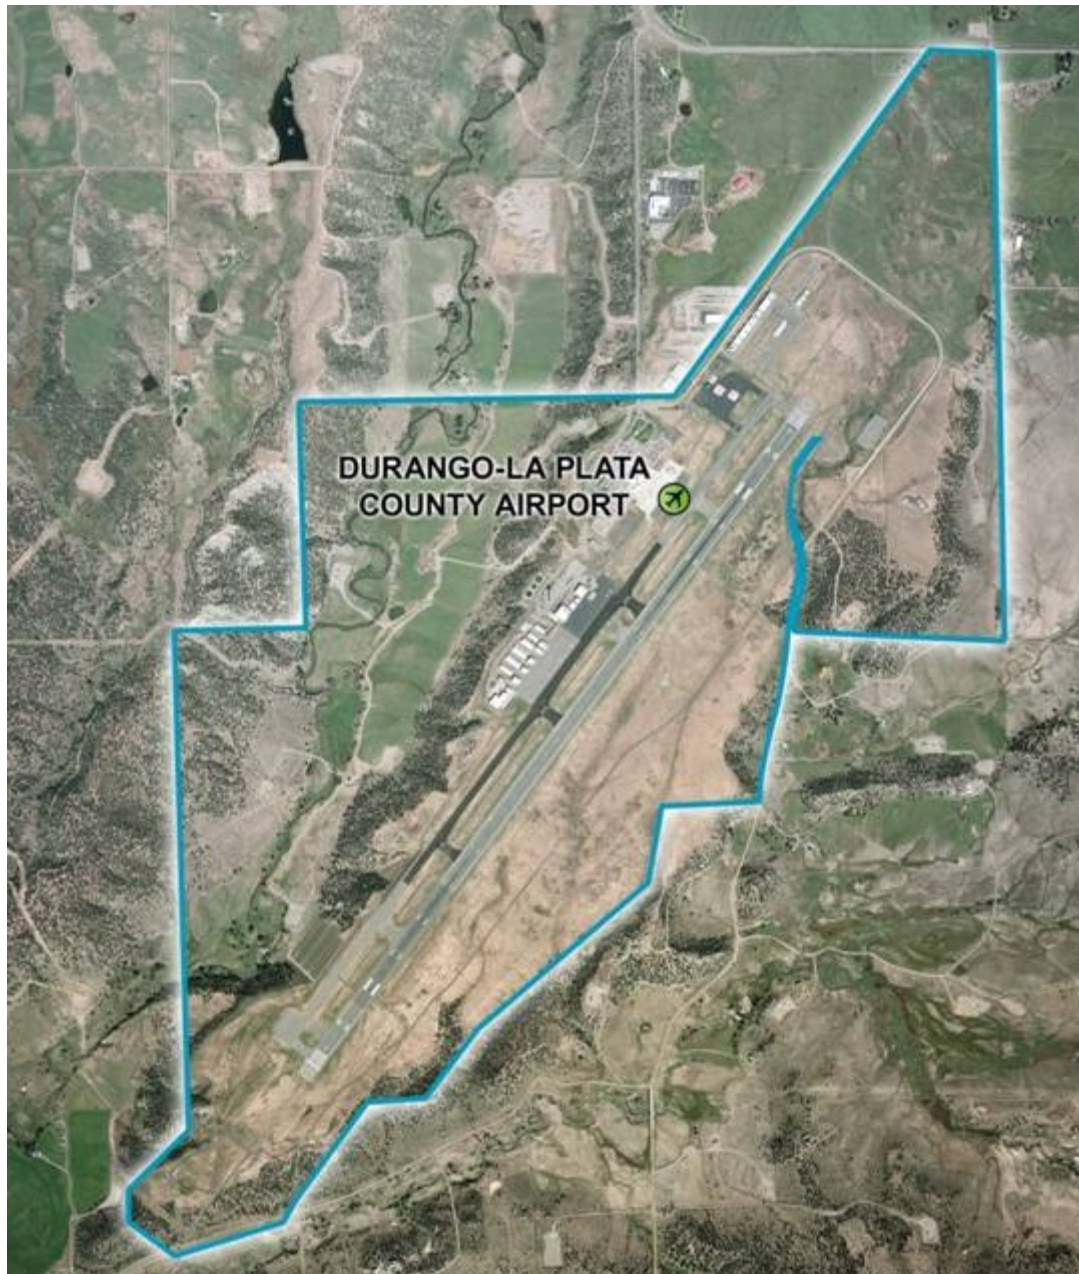
FIGURE 2-26 – EXISTING LAND USE SURROUNDING DRO

Land use classifications in the neighboring Southeast La Plata District do not exist within this District Plan.¹⁰ However, as shown in **Figure 2-26**, existing land uses adjacent to DRO and within the Southeast La Plata District are generally open land. Compatible land uses around an airport increase safety and aid in minimizing the effects of aircraft noise and environmental impacts. Incompatible land uses such as residential, schools, and churches are not located around DRO.
