DURANGO-LA PLATA COUNTY AIRPORT

Phase I Environmental Site Assessment

Prepared for:

Jviation, Inc.
900 South Broadway, Suite 350
Denver, CO 30326

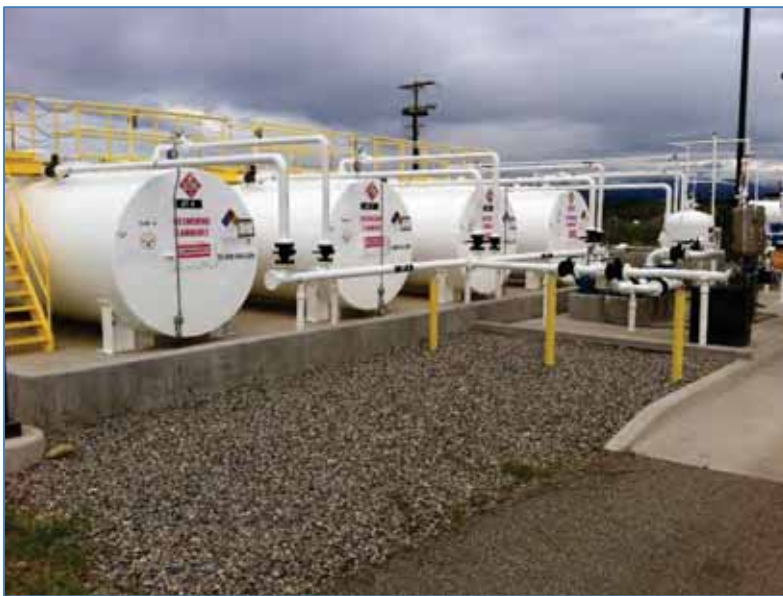
Photograph 1. Airport AVGAS Tanks

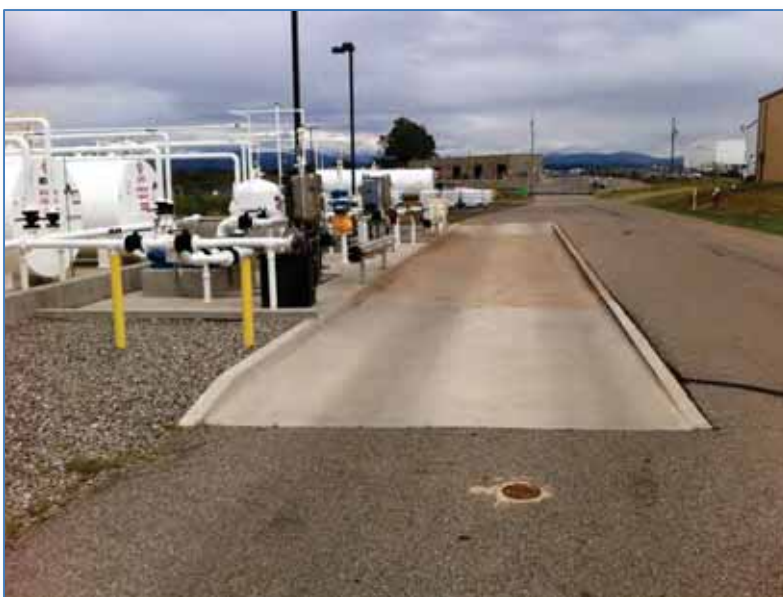
Photograph 2. Airport AVGAS Tank Dispenser area

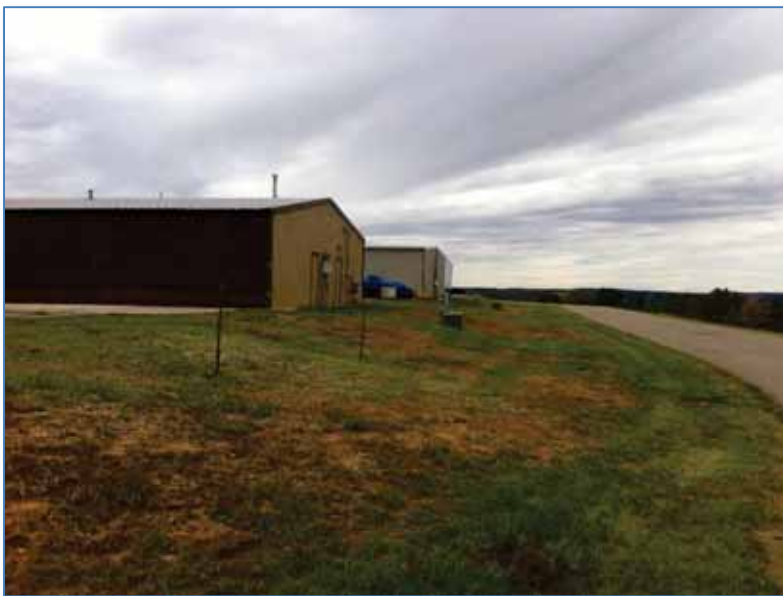
Each set of hangars has “green box” type transformer boxes owned by the La Plata Electric Association that are labeled “No PCBs” (Photo 3, Appendix C). There were no surface indications of leaks from the transformers.

Photograph 3. Airport hangars and “green box” transformers

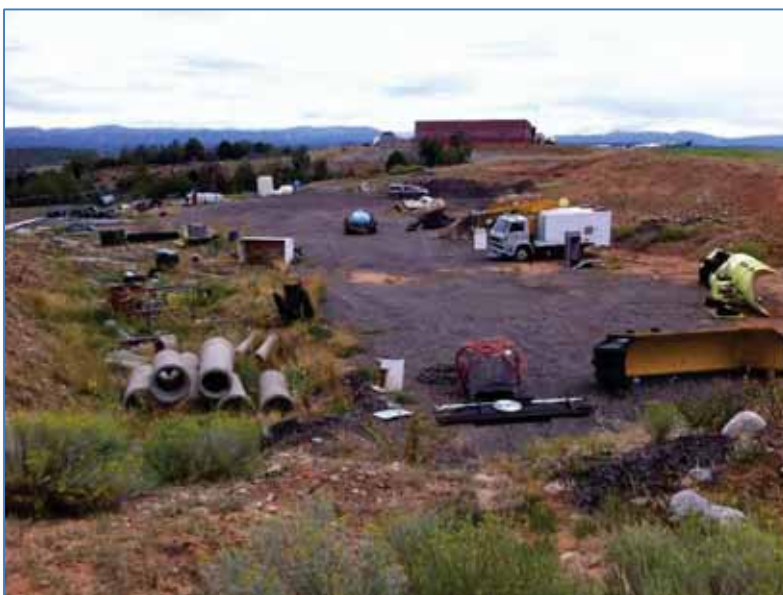
South of the maintenance building is an airport “boneyard” used to store tires, metal pipes, empty plastic tanks and drums, fencing, metal roofing, electrical wire, a truck, snow plows and two propane tanks on trailers (Photos 4, 5, and 6, Appendix C). No stained soil was visible during the site inspection.

Photograph 4. Airport boneyard

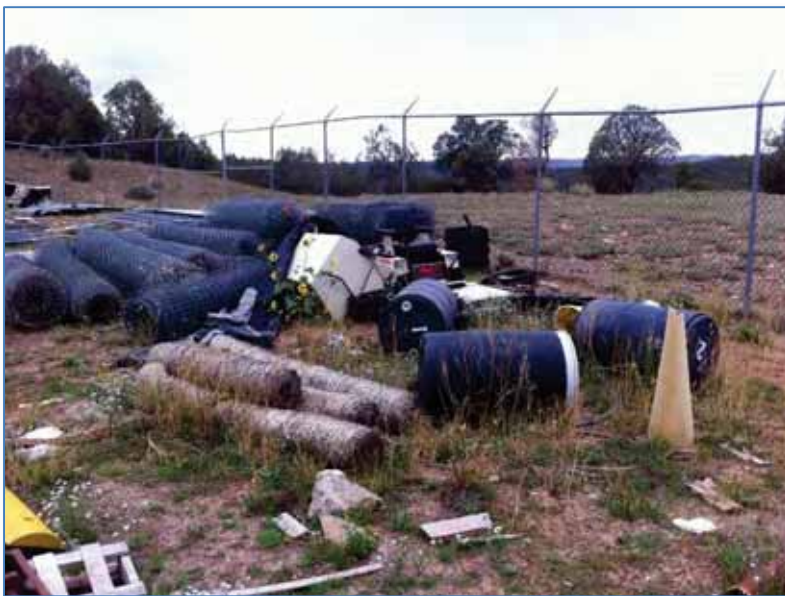
Photograph 5. Airport boneyard

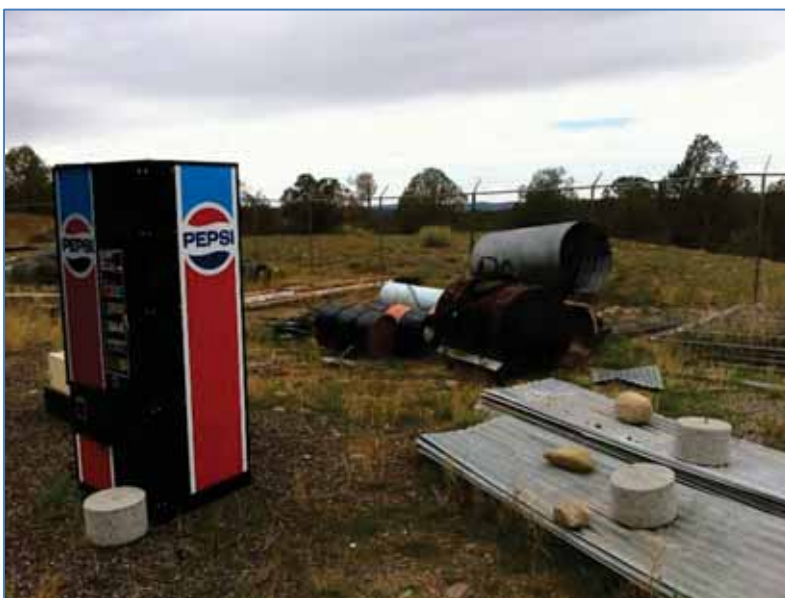
Photograph 6. Airport boneyard

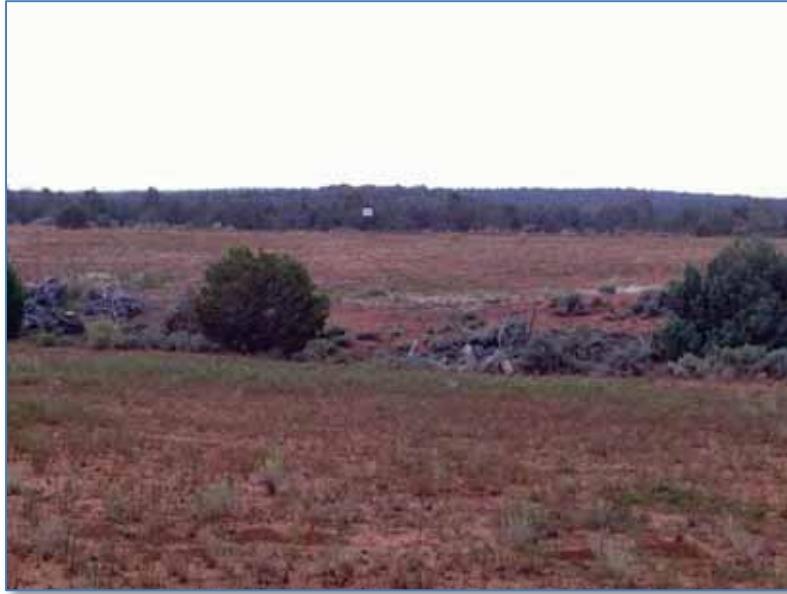
A small dump containing construction material consisting of metal, concrete, and chunks of asphalt was observed in an arroyo near the southeast end of the airport.

There is an asphalt stockpile area located near the southwest corner of the airport, and two fill areas located to the northeast and southwest end of the airport. The fill areas contain wood or concrete boxes with fence posts (Photo 7, Appendix C). No stained soil was visible in these areas during the site inspection.

Photograph 7. Dump in arroyo

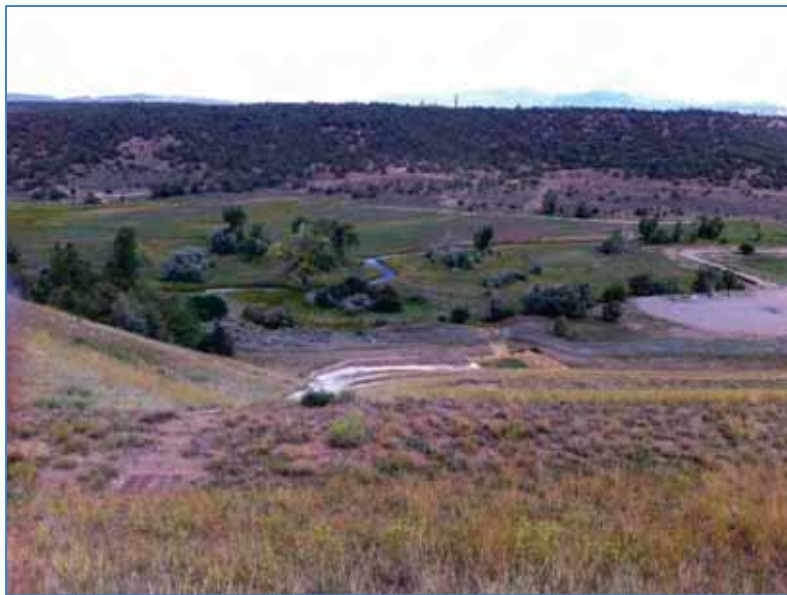
The third structural outflow is located west of the south end of the runway and drains the area between the west side of the centerline of the runway and the taxiway surfaces. This is primarily an erosion control structure and consists of a concrete rundown structure that spills into a riprap lined retention pond. It is also capable of being blocked in the extremely unlikely event of a spill of hazardous pollutants.

Photograph 8. Stormwater outlet near southwest corner of airport
