2. PURPOSE AND NEED

2.1 Statement of Purpose and Need

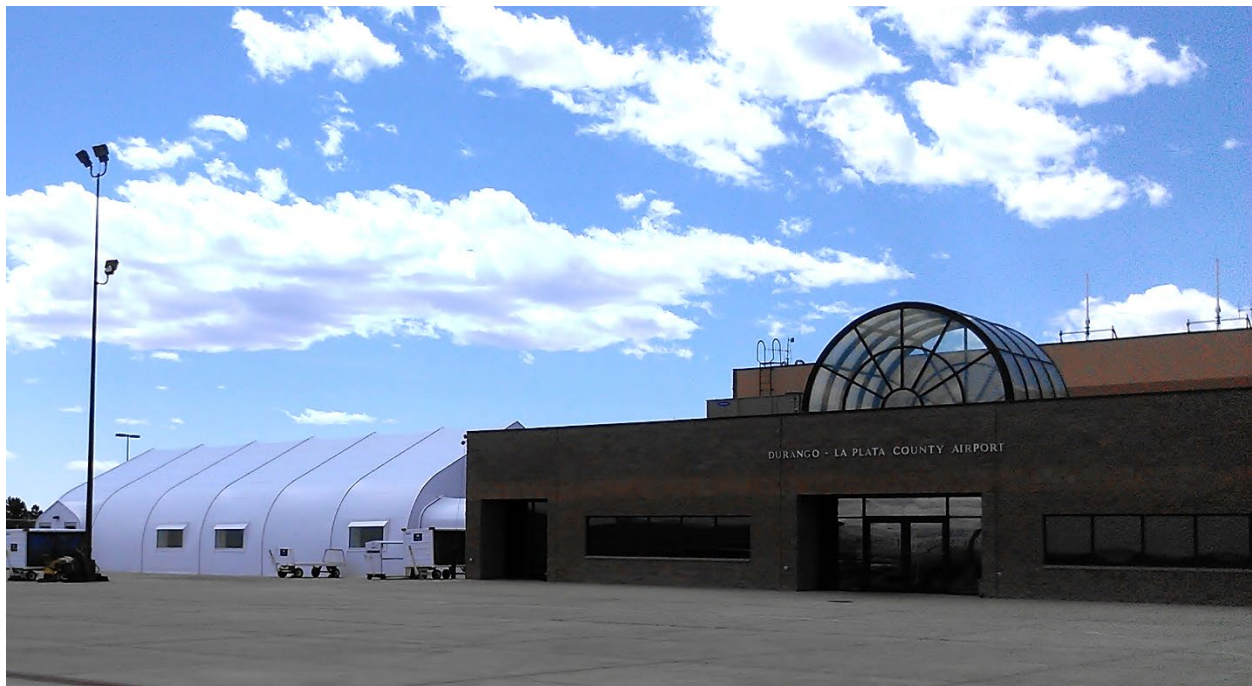
FIGURE 2-1 - DRO TERMINAL BUILDING

DRO's terminal building was originally constructed in 1987, with a temporary tent structure added in 2013 to accommodate the increased enplanements and expansion of the Transportation Security Administration's (TSA) security checkpoint (**Figure 2-1**). The original building consists of three concourses, shown in **Figure 2-2**.
